AUTO ASSURE
PRE PURCHASE INSPECTION

Pre-Purchase Vehicle Inspection Report

Ref: **SAMPLE-REPORT**
Inspected: **9 October 2026**
Generated: **18 November 2026**

MAKE Mercedes-Benz	MODEL X350d
YEAR 2019	REGISTRATION Hidden
VIN Hidden for privacy	BUILD DATE 2019
ODOMETER 117,699 km	TRANSMISSION Automatic
FUEL TYPE Diesel	LOCATION —

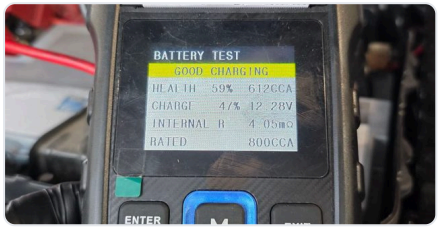
Battery health

Crank Voltage	10.5 V
Static Voltage	12.4 V
Charging Voltage	14.4 V
Overall Condition	Good
